Whitmore Ravine

Cascade County
Conservation
District

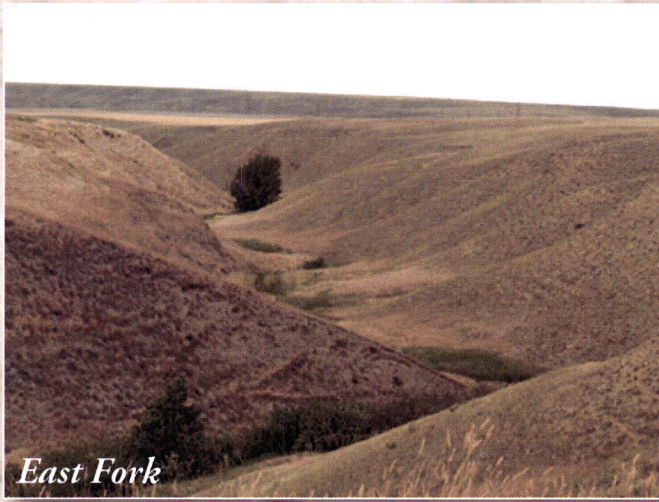
Erosion does not occur in the East Fork as it is in its natural condition, vegetated and stable, and is therefore able to handle large storm events. The East Fork does not receive any unnatural flows.
